BENNETTS MILLS DAM

PHASE I INSPECTION REPORT NATIONAL DAM SAFETY PROGRAM

NJ00088

JULY 1978

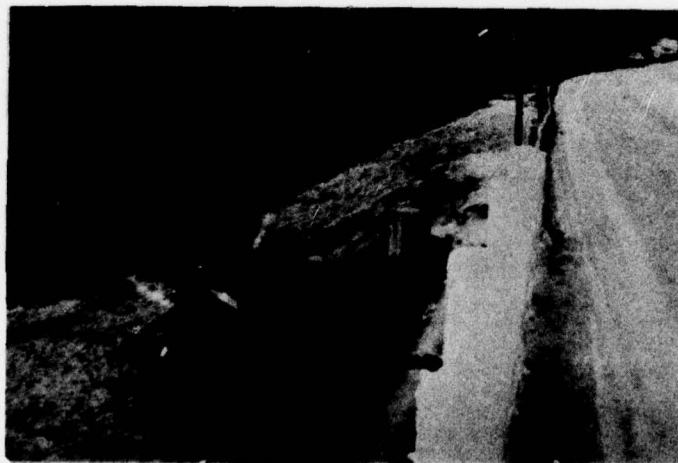
Photo 8 - View of the downstream roadway embankment slope looking toward the right abutment; the water impounding part of the roadway embankment ends approximately at the end of the guardrail

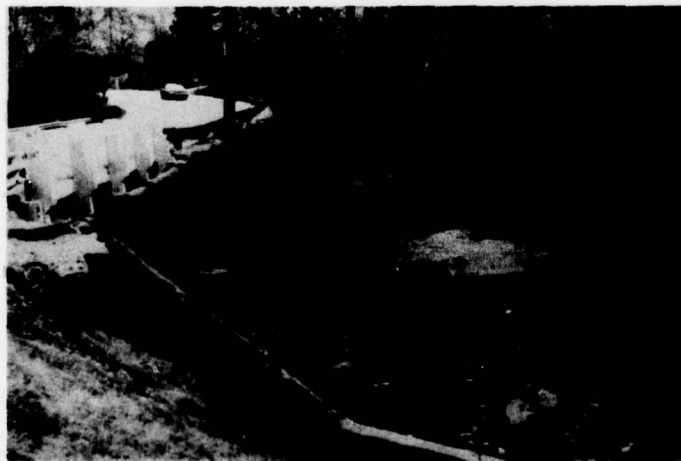
Photo 10 - Downstream face of the left timber bridge wingwall and the roadway embankment slope

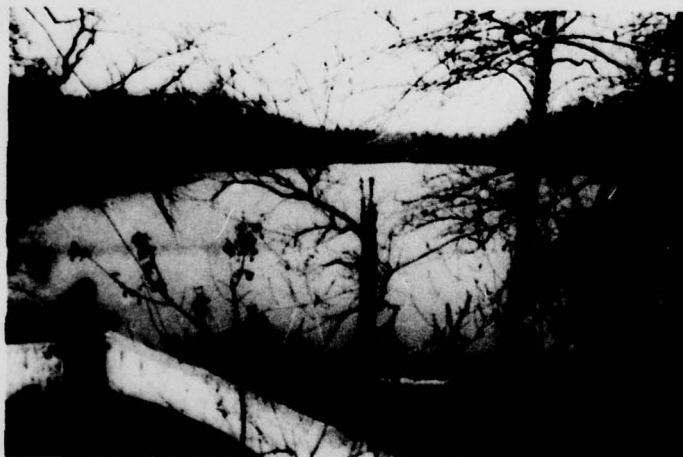
Photo 12 - View of the reservoir, looking upstream from the roadway
